# BATH HIGH SCHOOL RE-USE STUDY

Town of Bath, NC  
April 10, 2007

This report was prepared for the Town of Bath, NC, under a grant from the NC Rural Center to explore the feasibility of renovating the main buildings of the former Bath High School to serve new uses. It is a preliminary analysis of rehabilitation concepts for possible future uses of the property, rather than a specific development proposal or design.

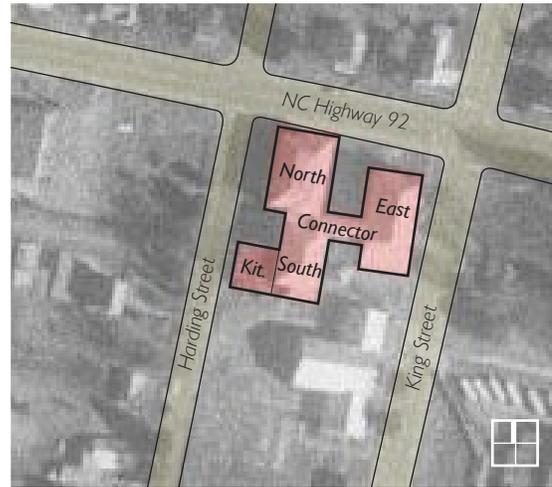
*Bath High School buildings*

The three main buildings of the high school are of similar construction and age, with load-bearing exterior walls of brick masonry, wood floors supported on brick piers over a shallow crawl space, wood stud walls or steel pipe columns for interior bearing, and built-up wood roof trusses. An engineer familiar with historic structures assessed the buildings in 2006 and found them generally sound and with minimal structural deficiencies, despite deterioration from numerous roof leaks over the years since closing. The report by DCF Engineering Inc., Cary, NC, is available from Bath High School Preservation.

Plumbing, electrical and heating/cooling systems all require replacement, and the buildings would require updating in light of life safety and accessibility codes that have come into being since the initial construction.

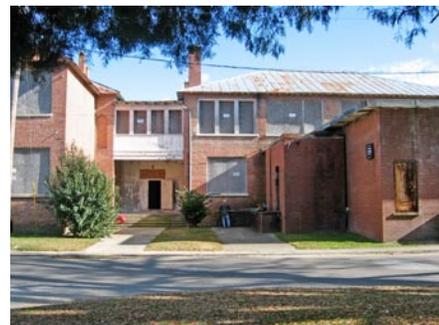
##### ***1. South Building***

The South Building, whose west elevation faces Harding Street, provided the first classrooms in the Bath school and may have been occupied as early as 1918. It was later used as the kitchen and cafeteria and ultimately, with all the interior partitions replaced with steel columns, solely as the cafeteria. With a footprint of 2,825 square feet (64.25 x 44 feet), the South Building provides 5,650 gross square feet of space. Ceiling heights are 12 feet on both levels.

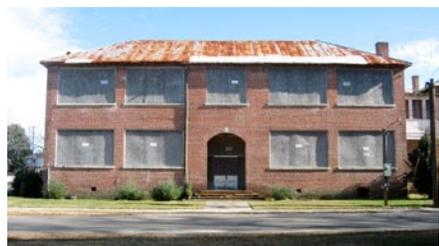
##### ***2. North Building***

The North Building was the second to be constructed and became the main point of entry for the Bath school. It housed the principal's office and classrooms, and had a footprint of approximately 4,000 square feet (74 x 54 feet). It provides a total of 8,070 gross square feet. Ceiling heights are 11'-9" on the ground floor and 12 feet

on the upper floor. Like the South Building, it also faces west, to Harding Street.

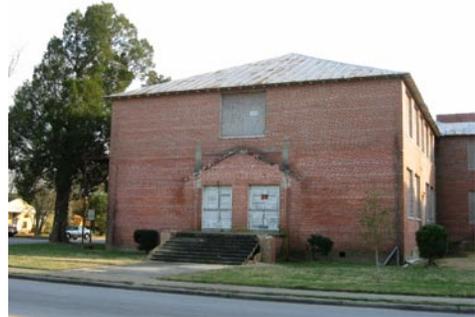
#### 3. *East Building*

The East Building, which houses the school auditorium and stage on the ground floor and additional classrooms above, was built third. It is the largest of the school's main buildings, with a footprint of 5,440 square feet (103 x 52.8 feet), or 10,880 gross square feet. Steel pipe columns support the upper floor. The lower floor slopes slightly for auditorium seating, which reduces ceiling height from 12'-6" at the front to 11'-10" at the last row of seats. Upper level ceilings are 11 feet above the floor. Unlike the other two buildings, the East Building's entry is on the shorter end, facing north. A wide porch and two sets of double doors front on Carteret Street. A gabled portico once sheltered the auditorium entry, but it was deteriorating and has been demolished.

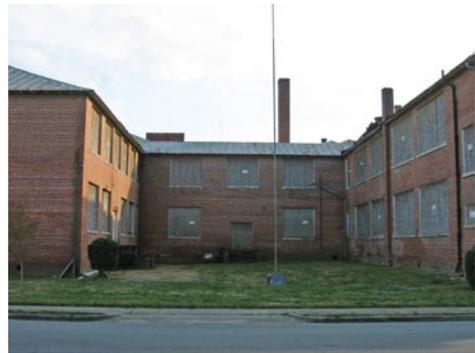
#### 4. *Connector*

A two-story, east/west connector built along with the East Building linked all three buildings with a generous 15-foot-wide corridor. It provided circulation, student lockers and lunchroom, and was stepped to meet the different finish floor levels in the buildings it connects. The connector has about 1,800 square feet on the main floor and nearly 1,700 square feet on the upper level, a total of nearly 3,500 gross square feet. Over the years, various rooms and closets have been partitioned in the space, narrowing the passage.

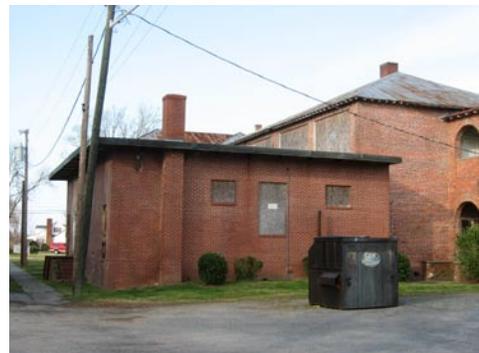
#### 5. *Kitchen*

The newest addition to the school complex, the Kitchen is a one-story, flat-roofed concrete masonry building with brick veneer, which was attached across the front of the South Building sometime during or after 1966, according to construction drawings. The addition contributes about 1,770 gross square feet (44 x 40 feet) to the school complex. Its detail and massing are not sympathetic to any of the original buildings, and it covers much of the original front façade of the South Building. Also, leaks in the flat roof system have deteriorated into several significant failures.
